May 17, 2018

Subject: Hazardous Material Assessment for Hawaii Health Systems Corporation,
Young Building First Floor Laundry and Maintenance Renovation Project,
Located at Leahi Hospital, 3675 Kilauea Avenue, Honolulu, Oahu, Hawaii

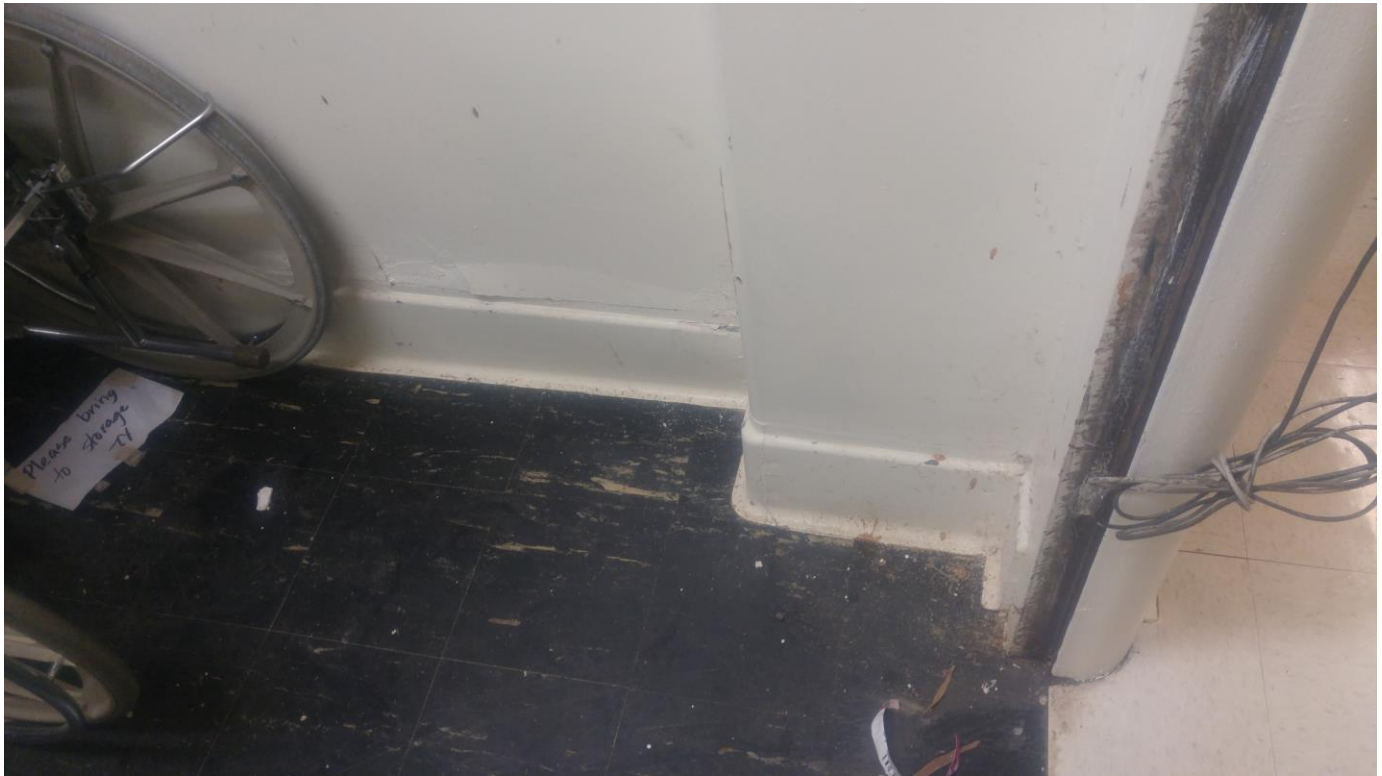
- Approximately 1,800 square feet of black 9-inch by 9-inch floor tiles and associated black mastic located in existing pharmacology rooms, existing doctor's office and existing storage rooms (photo 1)

Photo 1 April 26, 2018	Project Site: Young Building - First Floor – Leahi Hospital, Honolulu, Hawaii	Project No. TBG-180010
	Description: Asbestos-containing 9-inch by 9-inch floor tiles and associated mastic	
	Client: CKM Architects, LLC.

Asbestos-containing materials and lead-based painted building components shall be handled, removed, packaged and disposed of in accordance with State and Federal regulatory requirements. In addition, the disturbance of these materials shall be performed by trained and accredited Contractors under the supervision of a third party industrial hygiene professional.

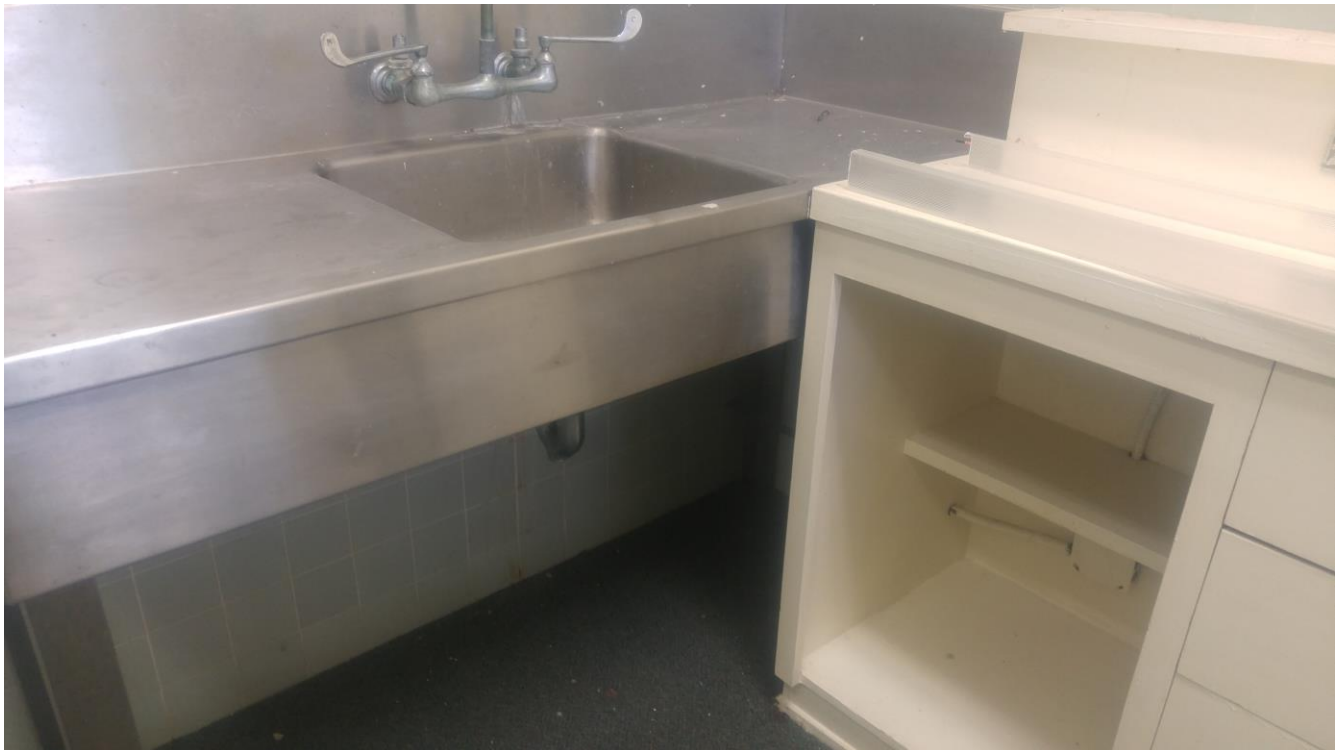
- One black sink undercoating in existing lab (Room 25-photo 2)
- Four sink underlinings (silver cardboard wrap) in Room 30, Room 27 and existing storage (two sinks - Photos 3 and 4).

Photo 2 April 26, 2018	Project Site: Young Building - First Floor –Leahi Hospital, Honolulu, Hawaii	Project No. TBG-180010
	Description: Asbestos black sink undercoating in existing doctor's office (Room 27).	
	Client: CKM Architects, LLC.

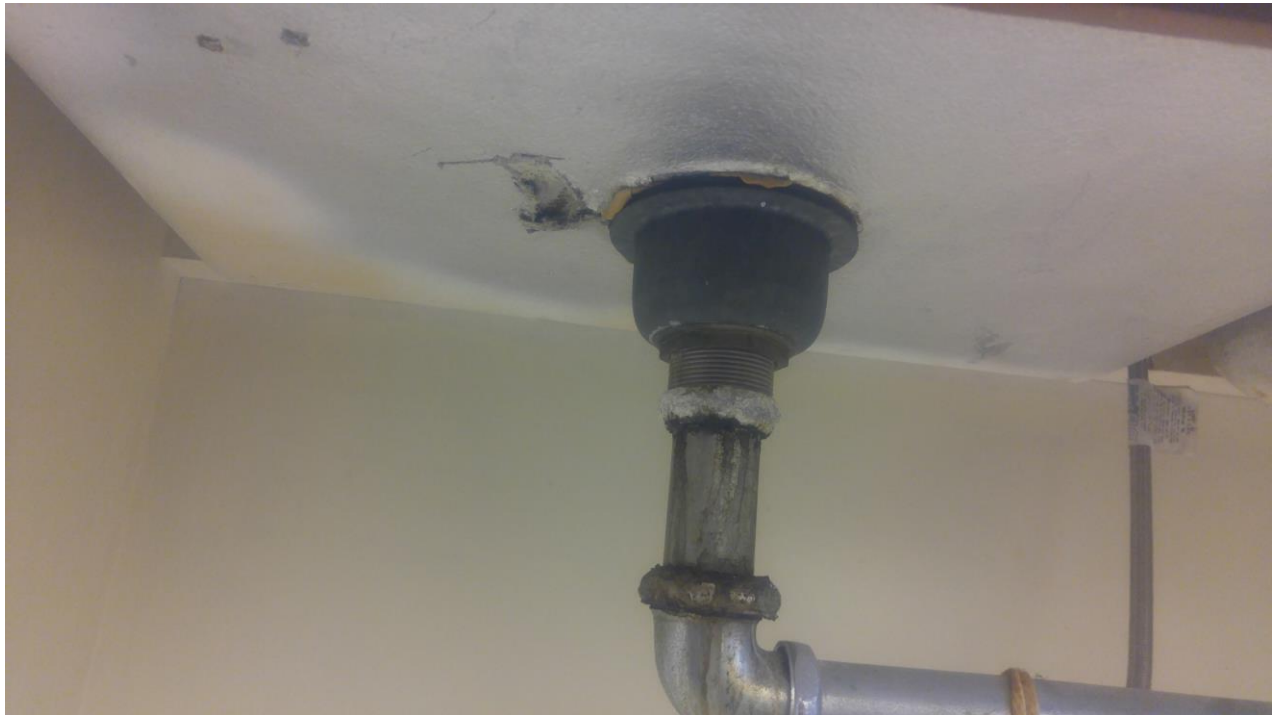
Photo 3 April 26, 2018	Project Site: Young Building - First Floor – Leahi Hospital, Honolulu, Hawaii	Project No. TBG-180010
	Description: Asbestos sink underlining in existing lab (Room 30).	
	Client: CKM Architects, LLC.

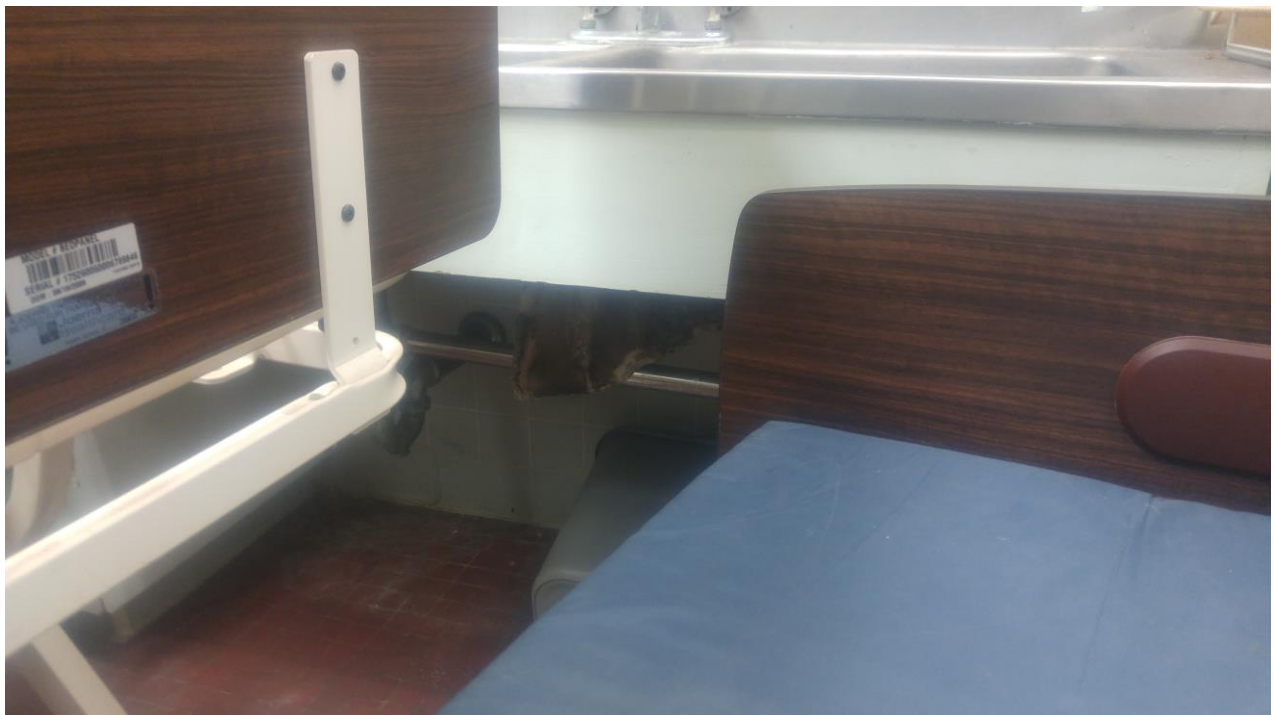
Photo 4 April 26, 2018	Project Site: Young Building - First Floor – Leahi Hospital, Honolulu, Hawaii	Project No. TBG-180010
	Description: Asbestos sink underlining hanging off sink in existing storage room (poor condition).	
	Client: CKM Architects, LLC.

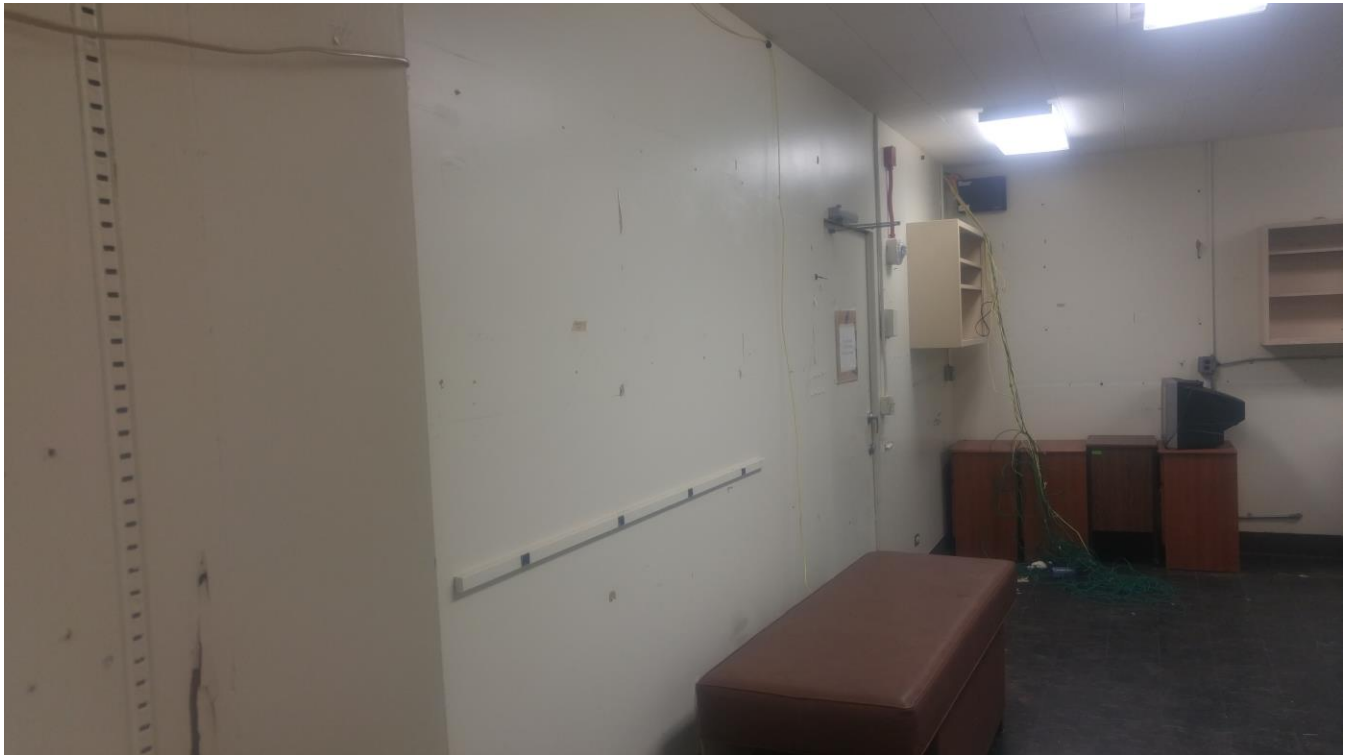
Photo 5
April 26, 2018

- Approximately 580 square feet of gypsum wallboard and associated mud located in existing storage walls, existing corridor and existing office reception (Photo 5)

Project Site: Young Building - First Floor – Leahi Hospital, Honolulu, Hawaii
Description: Asbestos-containing gypsum wallboard and mud in existing storage.
Client: CKM Architects, LLC.

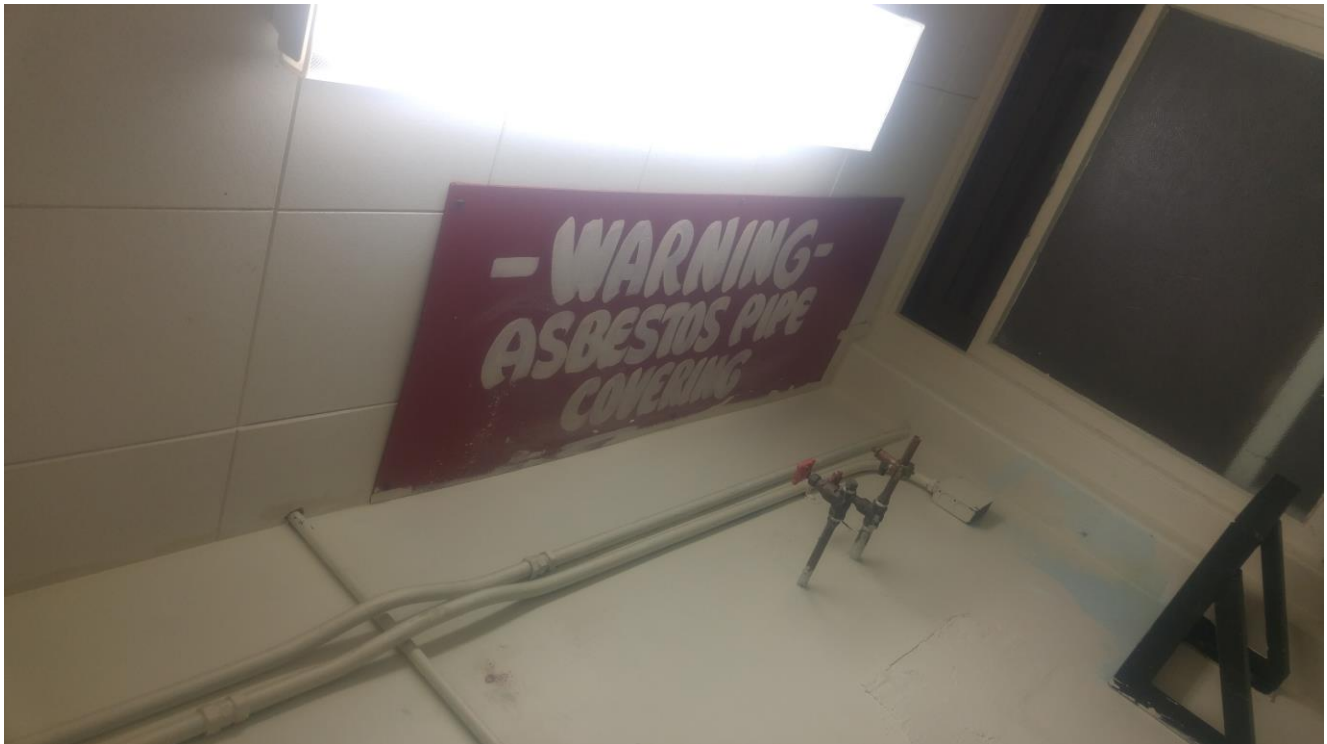
Photo 6
April 26, 2018

- Approximately 1,800 square feet of 1-foot by 1-foot fiberglass ceiling tile adhesive located in existing doctor's office (Room 27), existing storage rooms, existing lounge and existing work area (Photo 6)

Project Site: Young Building - First Floor – Leahi Hospital, Honolulu, Hawaii
Description: Ceiling 1-foot by 1-foot acoustical tiles with asbestos-containing brown mastic.
Client: CKM Architects, LLC.

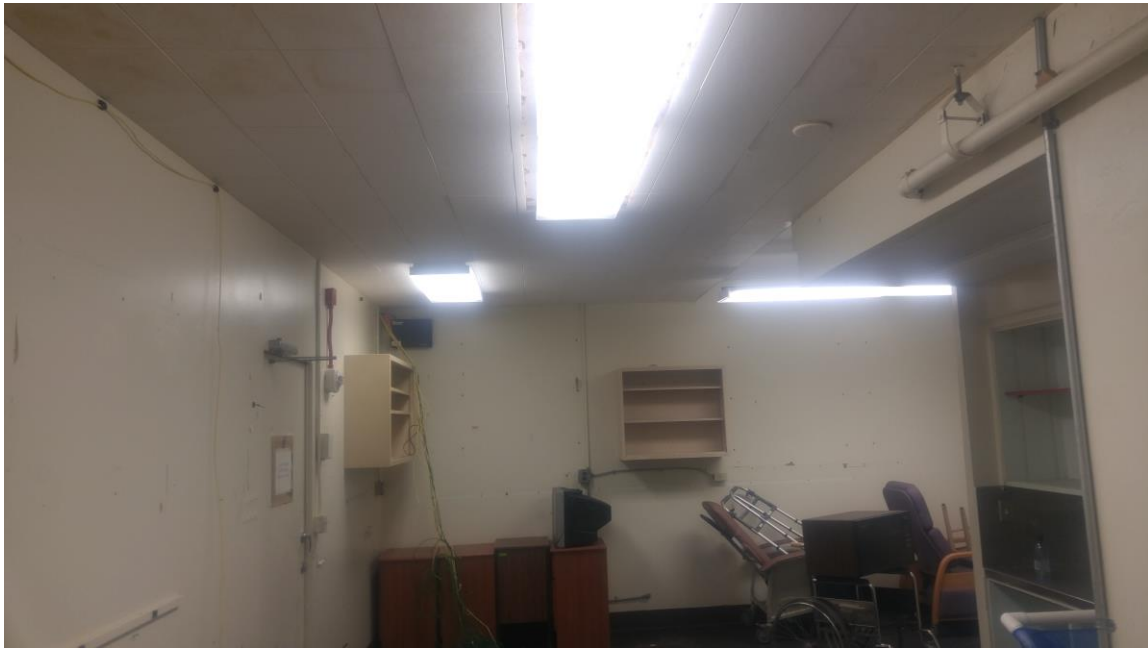
Photo 7
April 26, 2018

- Approximately 50 linear feet of 6-inch brown vinyl cove base with associated brown mastic on gypsum wallboard in existing storage room and existing office reception (Photo 7).

Project Site: Young Building - First Floor – Leahi Hospital, Honolulu, Hawaii
 Description: Brown 6-inch vinyl cove base on gypsum wallboard in existing storage room.
 Client: CKM Architects, LLC.

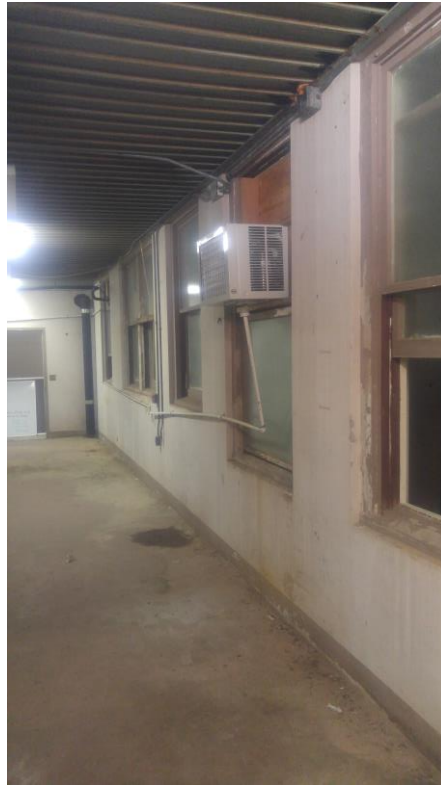
Photo 8
April 26, 2018

The laboratory reported lead at 3.5% lead by weight in the brown paint on seven wood window frames and sills located in the existing lanai area (future carpentry shop). This paint is above 0.5% lead by weight and is classified as LBP (Photo 8). Lead was reported in 16 paint samples at concentrations ranging from 0.018 to 0.34 % lead by weight. These paints are classified as lead-containing paint (LCP). Two paint samples reported lead concentrations below the method detection limit and are not considered to contain lead.

The laboratory reported lead above 0.5% lead by weight in the brown paint on the seven wooden windows and sills in the existing lanai area (future carpentry shop).

Project Site: Young Building - First Floor – Leahi Hospital, Honolulu, Hawaii
 Description: Brown LBP on window frames and sills in the existing lanai (future carpentry shop).
 Client: CKM Architects, LLC.

It is recommended that this report be provided to the Contractor performing the renovation work so that they may comply with the requirements of the Lead in Construction Standard for their employees who come in contact with lead.
